Bournemouth University

Heat Decarbonisation Plan

Full Plan

March2023

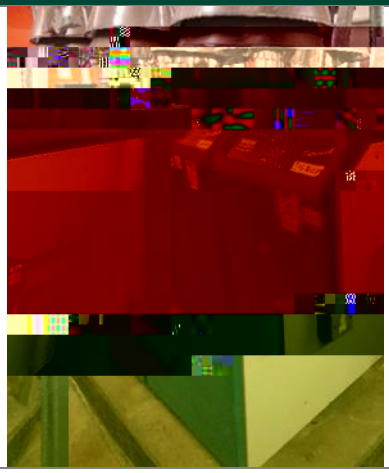
The plant room is located in the roof void and contains an air handling unit, the boilers, a DHW cyli
and the associated pump sets. Further plant is located externally, with two additional air handling u
and a chiller. The boilers are Hamworthy Purewell Classics with a combined maximum output of 285k
They are designed to supply two CT circuits, and one VT circuit which feed a combination of radiat
AHU coils and underfloor heating. The boilers also feed a DHW calorifier, however this is switched
to immersion heaters in the summer months to reduce gas consumption.

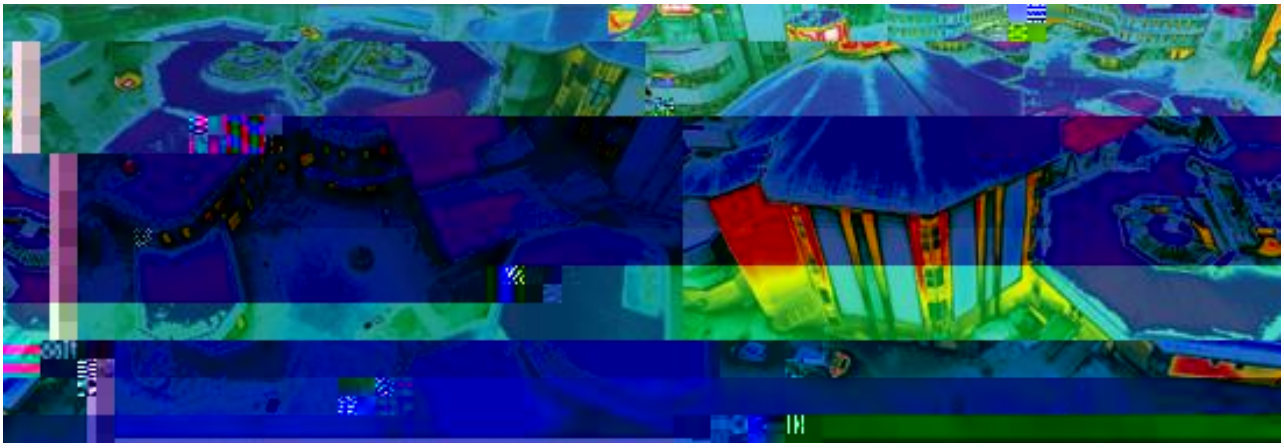
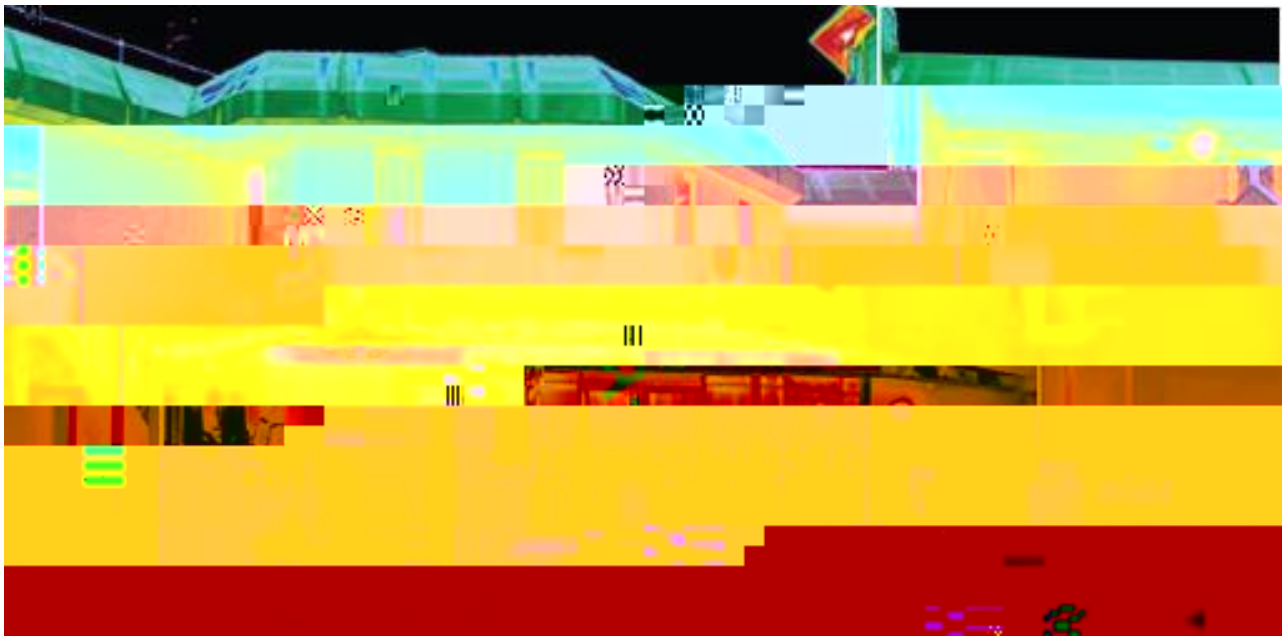
Talbot Campus - SMCL

- The roof appears to be in good condition, with a uniform temperature observed
- The biggest concern with this building is the glazing on the original construction. These appear to have varying levels of performance with some showing temperatures of ~15degC indicating poor installation or air leakage
- On all elevations, there is evidence of a thermal leak between the roof joins including the crown on top of the tower

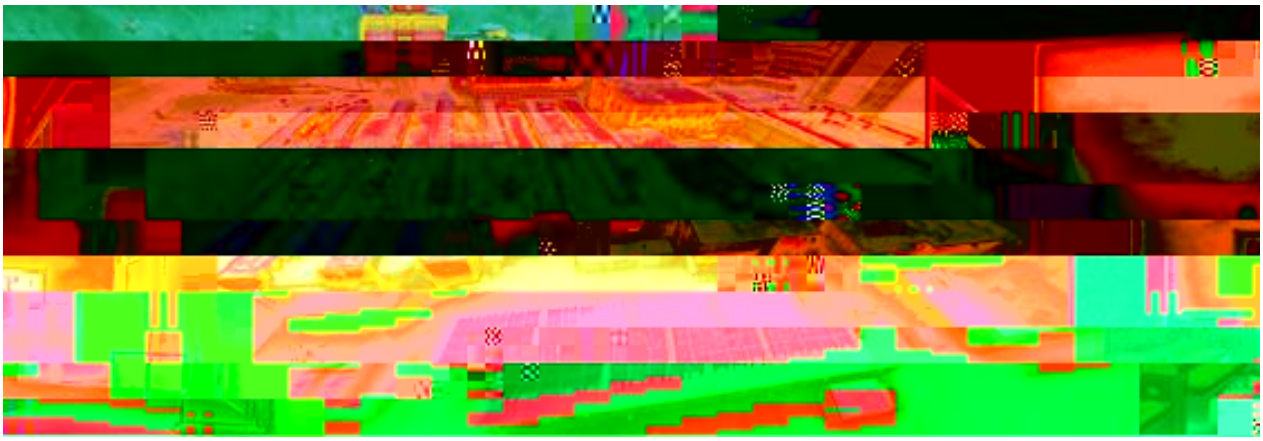
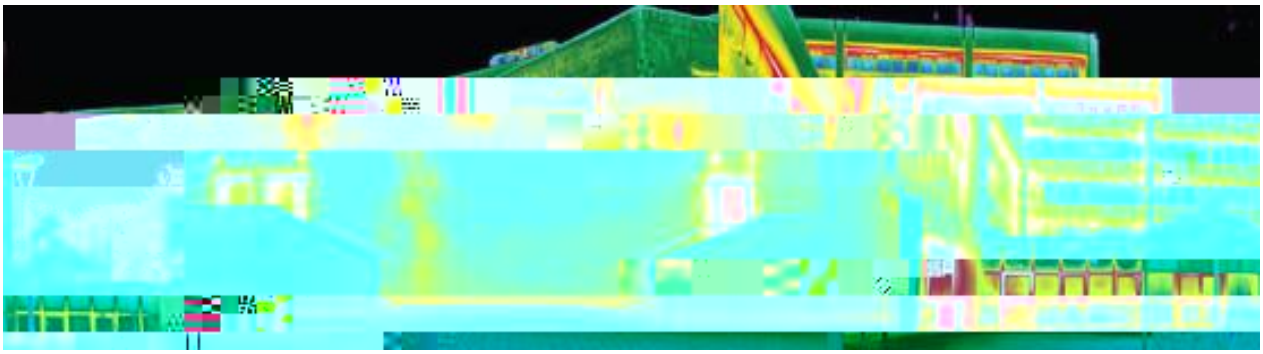
Talbot Campus - Poole House

- The roof appears to be in good condition, with a uniform temperature observed
- The southern elevation (by the Estates Reception) appears to either be missing insulation, or installed insulation has degraded significantly
- The glazing across this building is mixed, with some performing as expected and others performing very poorly

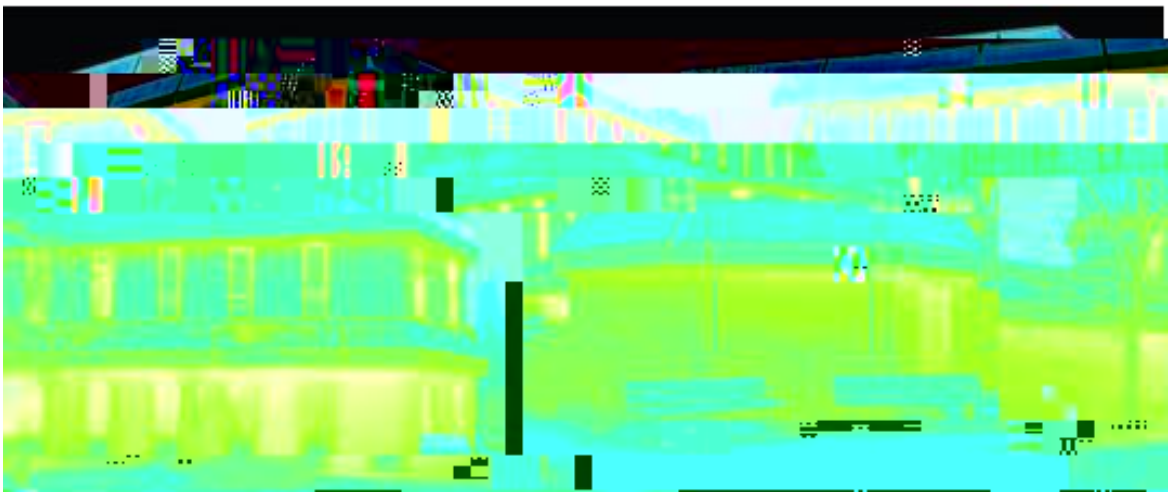
Talbot Campus Dorset House

- The windows, and especially their frames, are operating poorly which may be due to aging assets or poor installation W K D W K D V Q thHermal Performance L V H G
- There is a clear difference between the ground floors and the upper two stories, with the ground floor leaking considerable amounts of heat
- The roof covering looks good, with little to no signs of thermal bridging

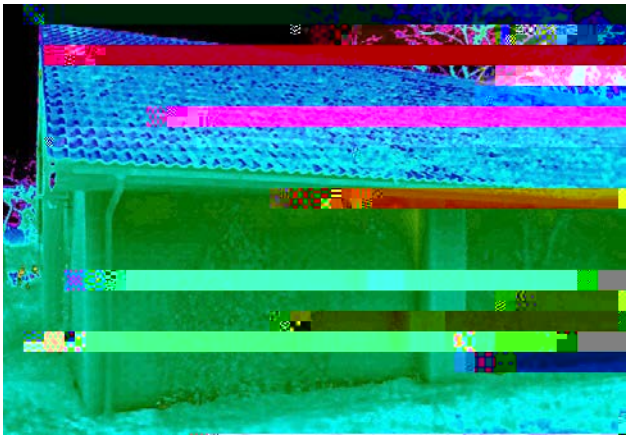
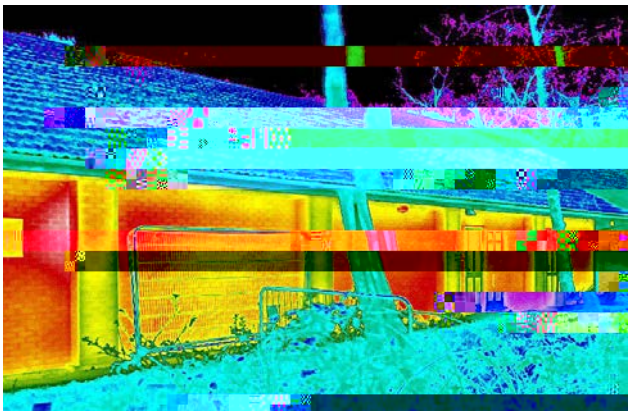
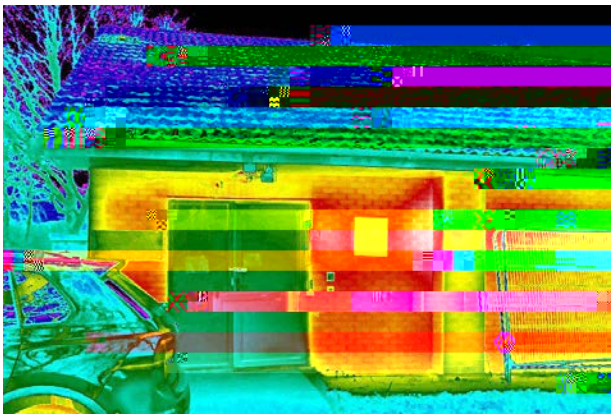
Chapel Gate - Tennis Club

- There are good even temperatures across some of the elevations suggesting that the insulation is performing well
- Minor areas of heat loss noted at the roof line.
- The temperature across the south elevation appears high further investigation is recommended in this area to ascertain insulation levels or other factors

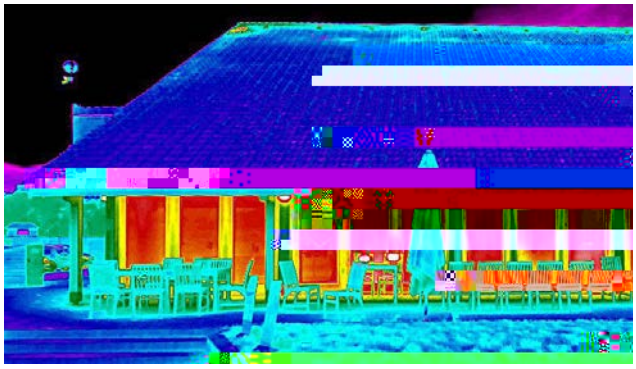
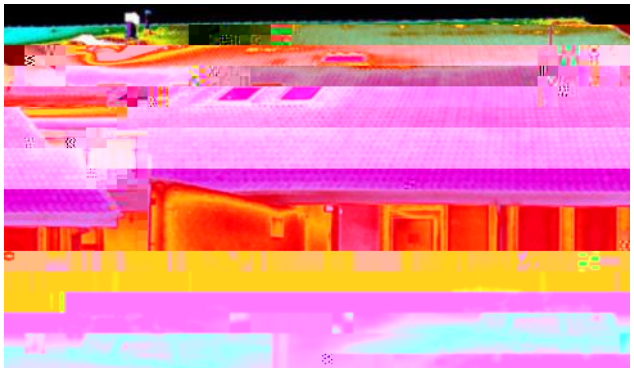
Chapel Gate² Sports Campus

- Overall, the roof and elevations show an even colour and temperature distribution, suggesting very little heat loss
- The windows, and especially their frames, are operating very poorly which indicating aging assets or poor installation not prioritising thermal performance
- The red vented areas should be investigated further for missing or misaligned insulation
- Insulation is performing poorly on both walls of the south elevation, it appears to have little or no insulation
- The door appears to be performing poorly, this should be investigated further as it was in constant use at the time of the survey
